Background and Purpose of Condition Assessment

The intent of this condition assessment is to independently evaluate the condition of Going-to-the-Sun Road. This assessment includes both a review of what had previously been investigated, concluded, and recommended regarding the condition of the Road, and two independent field reconnaissance missions, one in the fall of 2000 and one in early summer 2001.

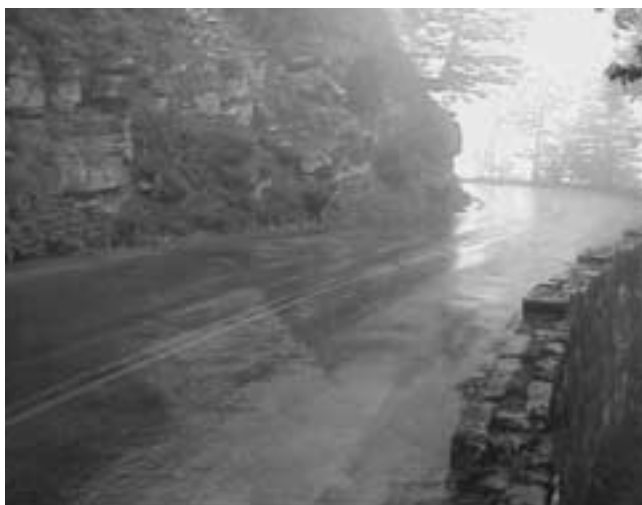
Figure 6: In some areas, natural drainage flows onto and across the Road. Additional culverts or cross drains would alleviate these problems.

structures are not providing adequate drainage and water is damaging the roadway pavement, roadbase, retaining walls, guardwalls, and the drainage structures themselves. Locations were noted where natural drainage flowed onto and across the Road (Figure 6). Deterioration of these features can be slowed by addressing the drainage issues along the Road. Solutions include cleaning of drainage ways, replacing existing culverts with larger ones, adding cul-

verts, installing weepholes or scuppers in stone walls, and properly locating cross-drains.

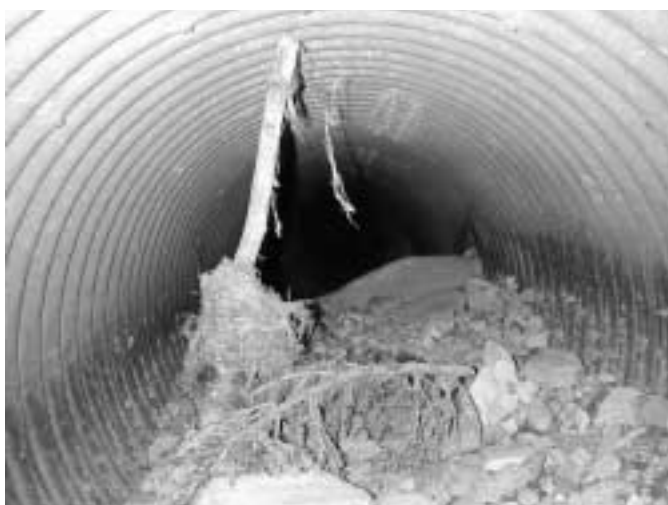
Figure 7: Rock and debris partially fill the entrance and interior of most corrugated metal pipe culverts, inhibiting drainage flow.

and only occasional incidence of abrasion. In some areas, particularly just west of Logan Pass, the drainage structures appear to be undersized for peak flow periods. Rock and other debris partially blocked the entrance to several culverts and the interior of most culverts, inhibiting drainage (Figure 7). Removal of this debris should be made a top priority by the park.

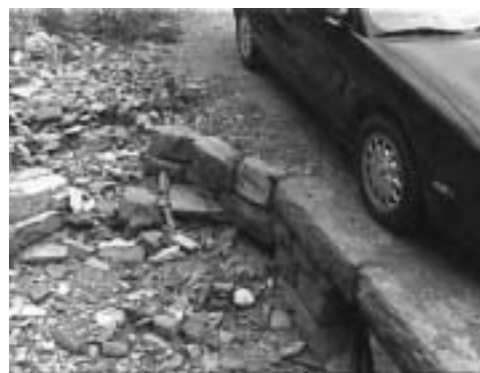
Figure 8: A roadside catch basin presents a hazard to vehicles.

roadway and into catch basins for dispersal. Catch basins exist along the edge of the Road; however, many of these are not grated and, due to their proximity to the traveled way, may pose a safety hazard (Figure 8). These catch basins should be modified to enhance vehicle safety with either log barriers or bollards.

Historically correct protection of roadside catch basins would involve placing log barriers in front of the basins to block cars from them. These log barriers would be removed to facilitate snow plowing. In most cases, replacing historic catch basins with drop inlets would not be historically appropriate.

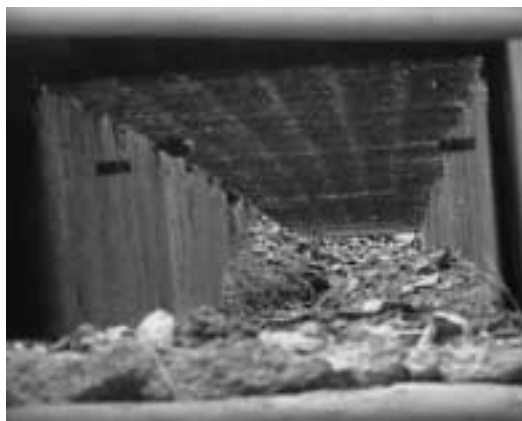
Figure 9: A cross drain is choked with debris, rendering it ineffective.

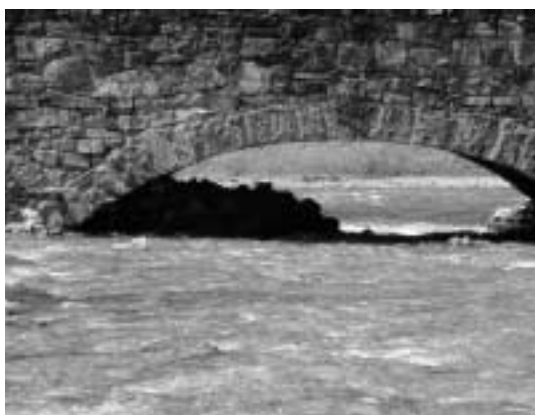
Figure 10: High bed loading at Logan Creek Bridge narrows the water channel.

Bridge, and Divide Creek Bridge all have high bed loading, which restricts flow. Each will require removal of this bed loading for proper flow and to reduce the deterioration on the structures and adjacent roadway.

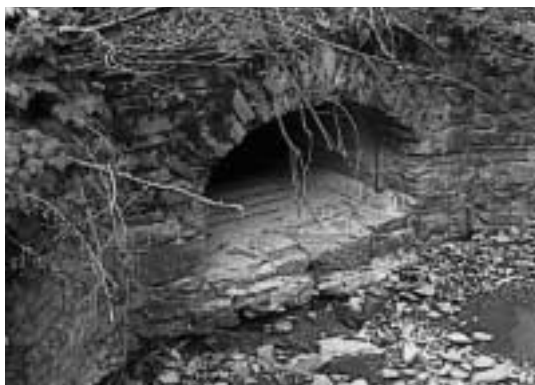
Figure 11: Bottom slab erosion at Haystack Creek reveals horizontal reinforcing bars.

Other box culverts and bridges along the Road are generally in fair to good condition, though notably not well maintained. Cleaning and repointing of the rock walls of these structures is needed throughout the length of the Road, in addition to repairs to the base of box culverts. Rock and debris abrasion has eroded the bottom of these culverts

to the degree that reinforcing steel has been exposed, promoting further deterioration (Figure 11).

Repairing the base slab of the concrete box culverts will not adversely affect the historic character of the Road.

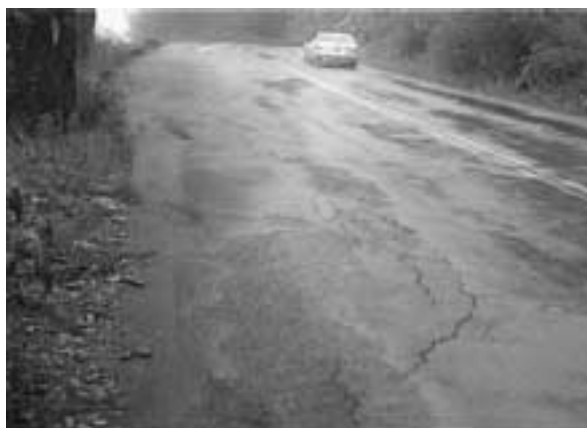
Figure 12: Weakened fill underlying the road.

- **Slump Failures.** Slump failures are generally limited to colluvium deposits and weakened fill sections adjacent to or underlying the roadway (Figure 12). Only a

few notable slump areas were observed along the roadway. No evidence of imminent sudden movement was observed at the time of this review; however, continued slow movements can be expected as a result of seasonal conditions and water intrusion. Slump failure areas should receive detailed analysis as part of future roadway design efforts. No specific recommendations can be made regarding these areas without location-specific geotechnical investigation.

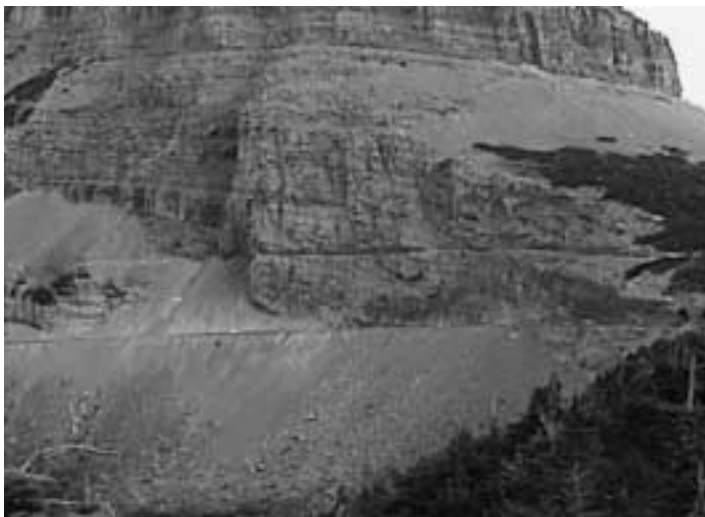
Figure 13: The most severe rockfall area is the quarter-mile section just west of Logan Pass.

The most likely section for severe rockfall hazards is the quarter mile section just west of Logan Pass, shown in Figure 13. The best type of mitigation for rockfall in this section would be to construct a rockfall shed or netting over the roadway. However, as noted above, this type of treatment would be highly intrusive on the historic and visual aspects of the Road. It is not deemed practical or effective to

undertake scaling or bolting measures in this section.

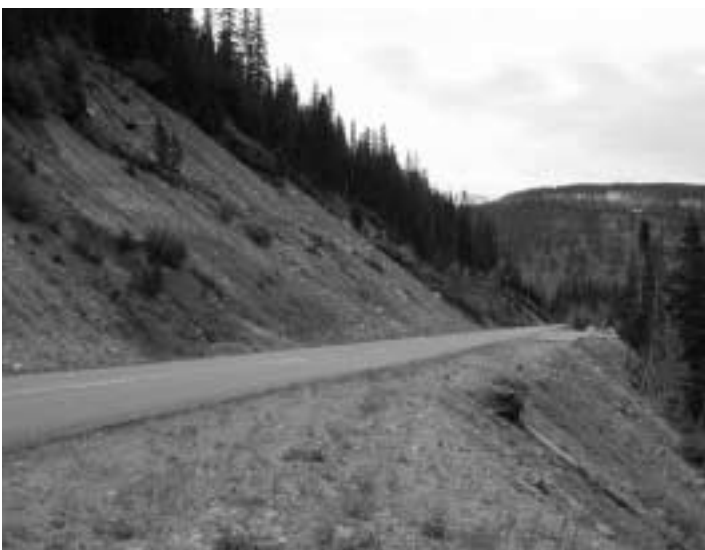
Figure 14: Unstable soil slope above the Road at MP 35

- ***Unstable Soil Slopes Above the Road.*** In several locations steep, unstable soil cuts lie

immediately above the Road. These soil cuts are subject to erosion, which is undercutting the ground surface at the top of the cuts. Such erosion also causes boulders to be eroded out from the soil material, leaving them free to tumble down the slope and onto the Road. Provisions must be made at these locations to retard erosion and/or to prevent boulders from entering the roadway.

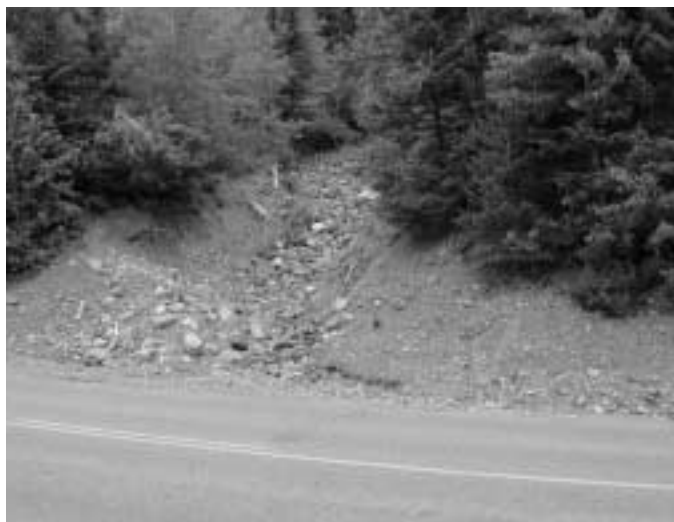
Figure 15: Debris flow at MP 37.

- **Debris Flows.** Debris flows have a significant impact on maintenance requirements and, potentially, roadway users. Debris flows are generally confined to gullies and drainageways; however, there is a hazard of sudden flow onto the Road, sometimes of considerable volume. There is little that can be done to prevent them. The flow of debris onto the Road can be reduced by placing barriers in the gullies and drainageways; however, they may be visually intrusive.

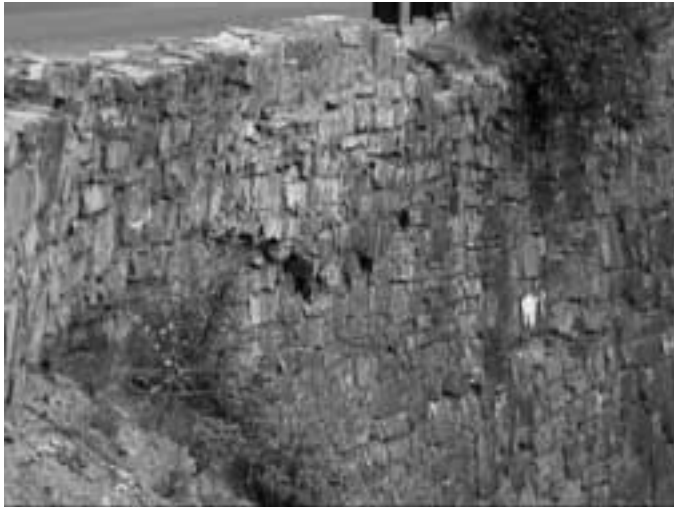
Figure 16: Retaining wall at MP 27.

Considering the age of these walls, they are in generally fair condition, with a few notable exceptions. These exceptions include

five walls that are considered damaged beyond practical repair due to failed foundations, water intrusion, and stone displacement. Portions of these walls must be rebuilt and FHWA will complete the work within the next two years.

Also, the upper three to eight feet of many of the walls are in distress, with loose or missing stones and crumbling mortar. Almost all of the mortared walls exhibit some degree of joint and mortar deterioration; these walls should be repointed (the old mortar removed to the extent possible and replaced with new mortar). In many instances vegetation is growing in the mortar, which indicates soil contamination and moisture intrusion. The bottom portions of the walls are generally in fair condition.

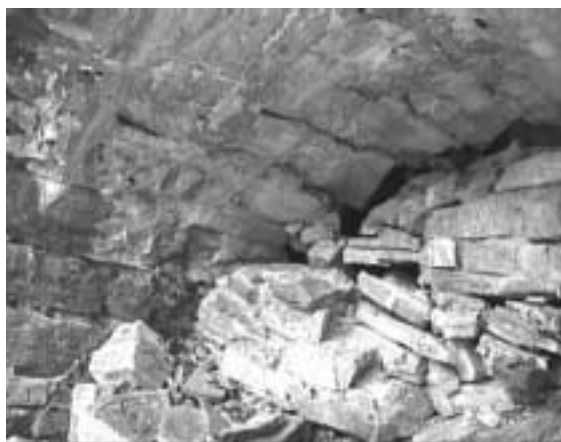
Figure 17: A portion of Crystal Point Arch has collapsed.

Crystal Point Arch is considered one of the finest examples of workmanship and classic design anywhere in the park. As such, it must be treated with the greatest of care. The craftsmen who originally built this arch selected and placed each stone carefully to match the color and texture of the stones around it. For exceptional structures such as this, it is recommended that, should any disassembly be required, the stones be numbered for correct reassembly.

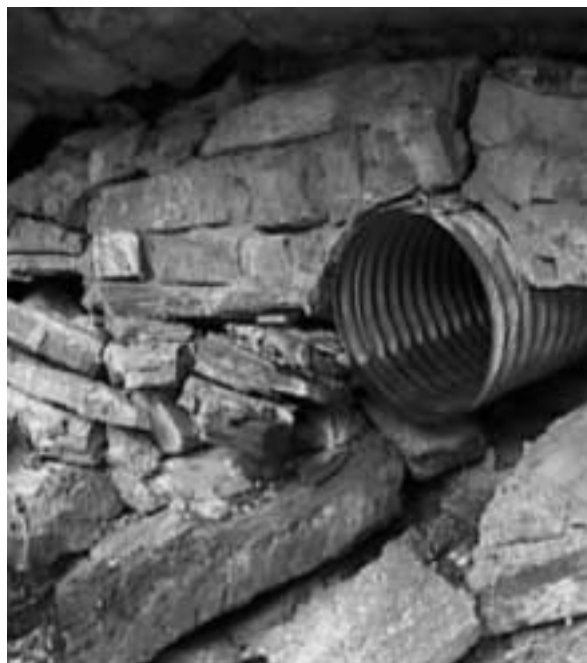
Figure 18: Corrugated metal pipe underneath Crystal Point Arch.

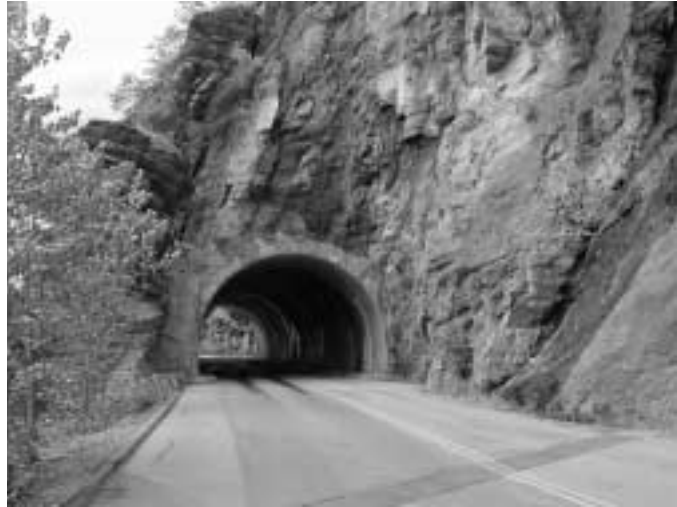
Figure 21: West Tunnel

- **West Tunnel.** No action is needed other than addressing rockfall issues and stone masonry repairs at the east portal and rockfall potential above the window vista near the tunnel's west end. Loose rock should be removed or stabilized in these areas as a safety consideration. Cracks in the tunnel lining appear well healed and are considered benign at this time.
- **East Tunnel.** The tunnel is in good condition and no action is needed at this time. Portal areas should be watched for loose rock, and scaled as appropriate.

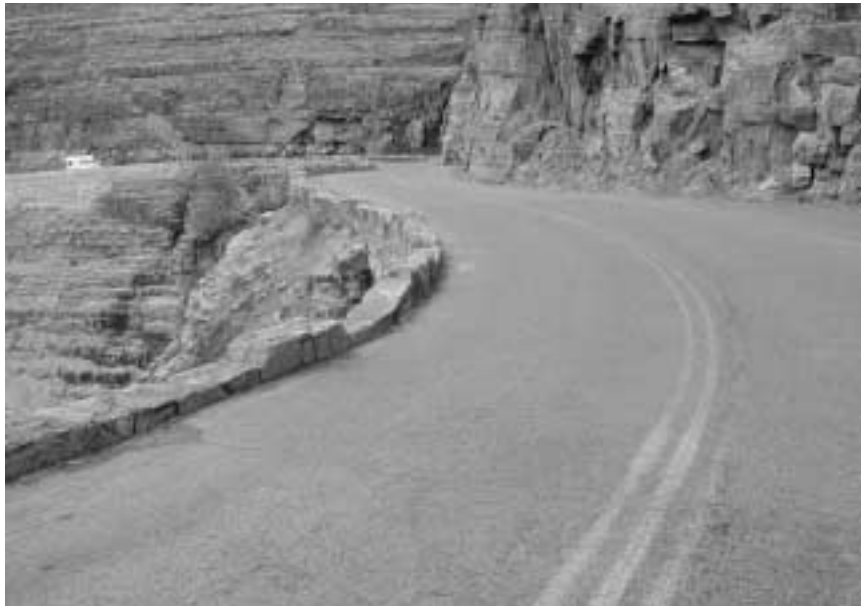
Figure 23: In some cases, the distance from the top of the guardwall to the top of the cliff is as little as six inches. The majority of the stone guardwalls are leaning away from the Road or have been outwardly displaced from the roadway due to poor drain-

age and foundations, avalanche and snow weight pressures, poor maintenance practices, etc. Many have also settled. The general condition of these guardwalls is considered poor, and the repair and reconstruction of certain sections is considered a high priority. Many of the guardwalls need repointing and other rehabilitation work.

In some cases the distance from the top of the roadway to the top of the guardwall is as little as six inches, rather than 18 to 24 inches, as illustrated in Figure 23.

The guidelines for repointing and rebuilding historic guardwalls are the same as for stone retaining walls. Additional guidelines for the rebuilding of guardwalls include that the size (height, width, length) and location of the battlements (i.e. the “steps” that occur every so often) should be maintained; the historic type of guardwall, ashlar or random rubble, used at a particular location should be retained. If necessary, a concrete footer may be built underneath the guardwall before it is rebuilt as long as it is concealed by the finished stone product and results in no displacement of the wall from its original position (lateral, vertical, or horizontal).

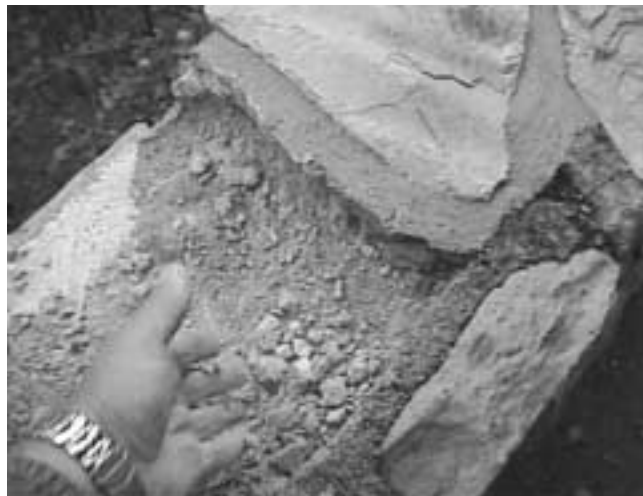
Figure 24: Replacement mortar consisting of fine sand has almost no strength, and can be readily crumbled by hand.

Some of the stone guardwalls appear to have been reconstructed or repaired with a mortar consisting of fine sand, such as would be used for brick or concrete masonry work. As illustrated in Figure 24, this mortar has almost no strength, and can be readily crumbled by hand.

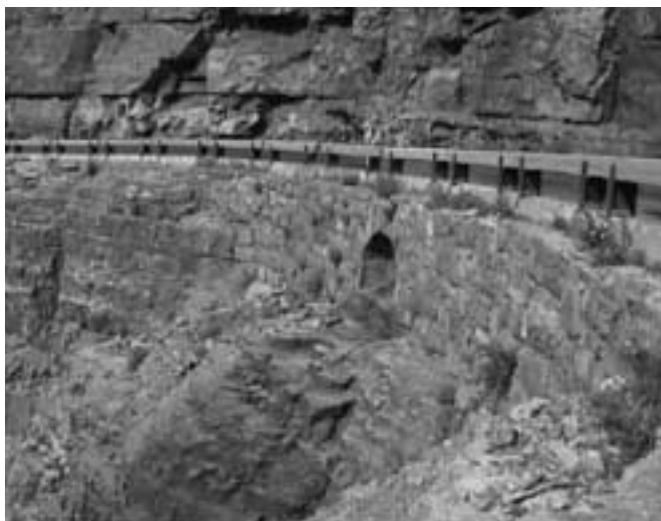
Figure 25: Removable sawed timber rail and steel post on concrete foundations.

- **Removable Sawed Timber Rail and Steel Post on Concrete Foundation.** These guardrails function as “removable” rails in avalanche zones and are generally in good condition (Figure 25). These guardrails were not intended to be crashworthy, rather only to serve as delineation. These removable guardrail systems are non-historic.

The current sawed timber rail and steel post removable guardrail is not historic and its use should not be proliferated. Because it is historically inaccurate, replacement of existing installations is recommended. An acceptable alternative, in historic stone guardwall locations, is avalanche-resistant stone guardwall. This is a concrete stem wall with stone veneer that looks like original guardwall. Round-log guardrail designs have been historically used in some other locations, the reuse or adaptation of this design may be considered.

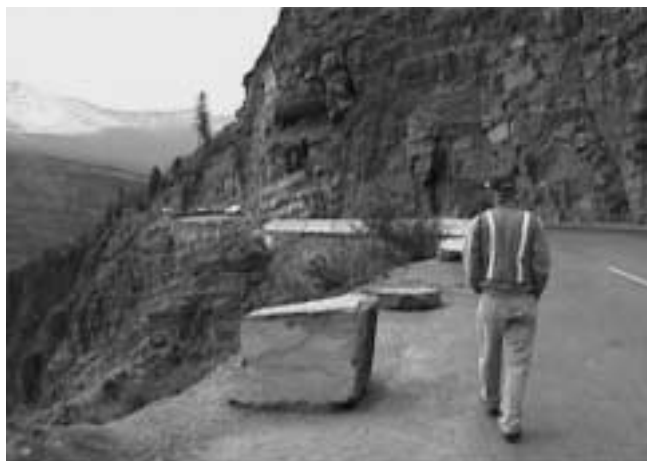
In most locations, barrier rocks are not historically accurate and are not necessarily desirable from a safety standpoint. Most have been added since the 1950s or 60s, although it is reported that drawings from 1938 show isolated curb stones of 15 to 20 cubic feet for placement on the Transmountain Road. In most areas their function is to block vehicles from informal pullouts. These pullouts were created in many cases by maintenance activities that resulted in excess earth and rock material being deposited alongside the Road, resulting in a wide spot near the Road. The most historically correct action would be to remove the slide debris from alongside the Road and recontour the slope. Alternatively, the debris area could be revegetated. Either way, the informal pullout would no longer exist and the barrier rocks could be removed.

Figure 26: Large barrier rocks are used to block vehicles near the edge of a cliff.

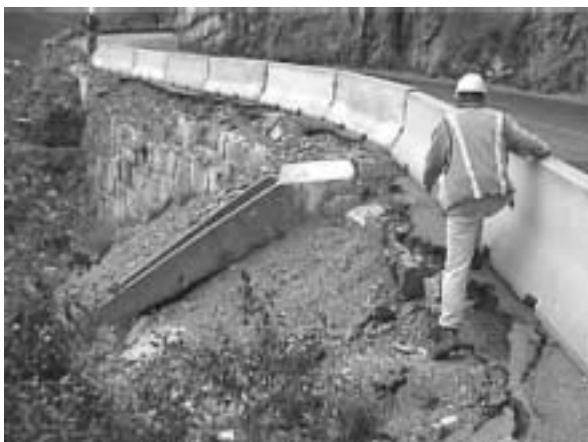
Figure 27: Temporary concrete “Jersey” barriers replace missing guardwall, a dramatic visual departure from the original.

barriers be replaced with historically appropriate stone guardwalls or guardrails.

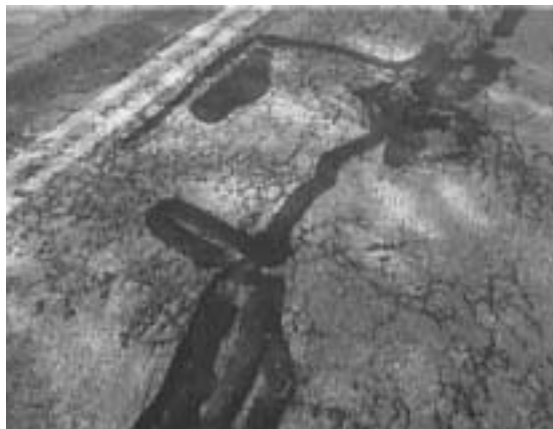
Figure 28: Cracks reaching down into the roadbed.

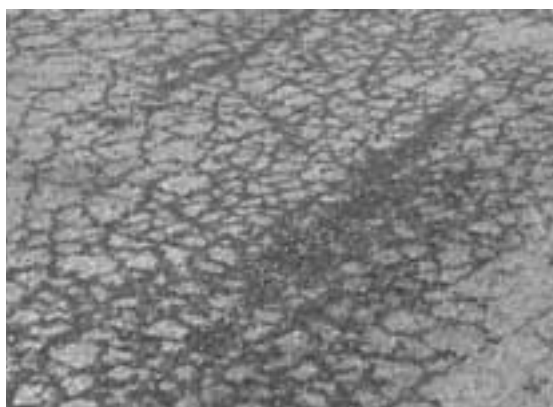
Figure 29: Alligator cracking.
